Site Visit Report

Date: 08/25/20
Client: Dudley Planning Board
Project: Pierpont Estates
Contractor: Tony Cerqueira
Contractor Contact: Tony Cerqueira

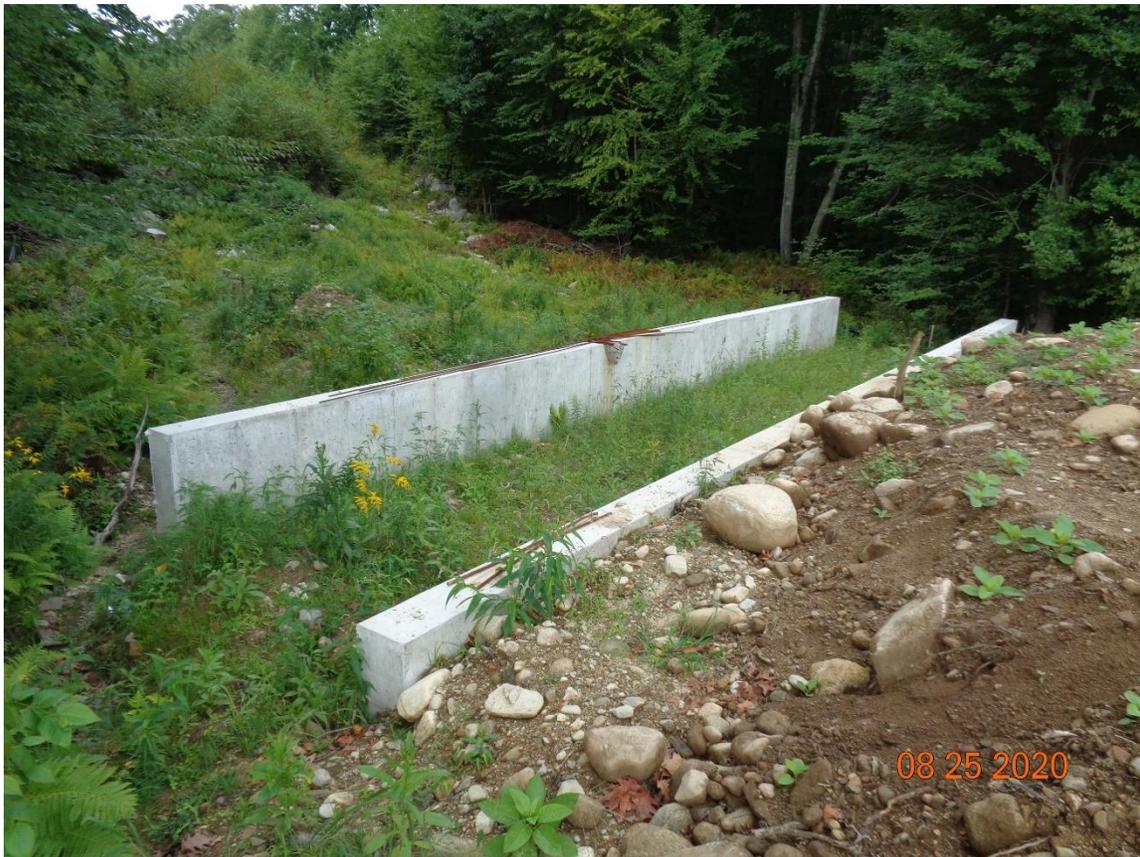
At the Noble Street station 14+20+/- wetland crossing, the two concrete walls were twelve inches wide and 55 inches high as measured from the top of the footing to the top of the walls. The interior width of the culvert was twelve feet between the walls and the walls were approximately 54 feet long. On the west side of the culvert, the footing was eleven to twelve inches thick and extended approximately one foot beyond the wall.

Outside the culvert, the east side had been backfilled and the west side had not been backfilled. Inside the culvert, backfill material had been placed and rough-graded, but the backfill material had not been placed fully against the retaining walls, and the stream channel had not been re-established.

In order to achieve an “Openness” of at least 0.25 meters (0.82 feet) as required by a note on Sheet 3.7 of the approved plans and the Army Corps of Engineers Stream Crossing Standards, the open height will need to be at least 3.7 feet (44”) within the culvert as measured from the backfill material within the culvert to the top of the walls. As currently rough-graded, the height was approximately 40 inches at the inlet (south) end of the culvert and approximately 48 inches at the outlet end.

Culvert's concrete walls at Noble Street station 14+20+/-, looking from the east side of the culvert.

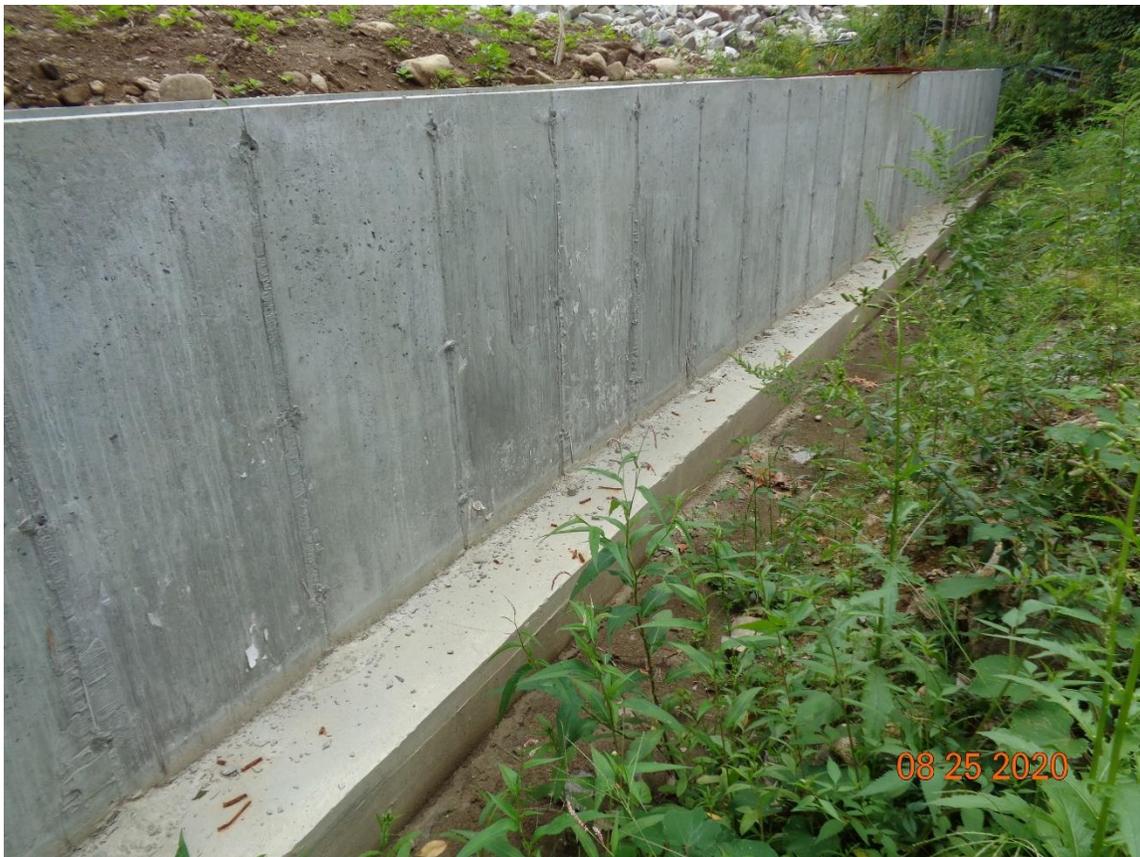
Culvert's concrete footing and walls at Noble Street station 14+20+/-, west side of culvert.
